Foundation Failure

We experienced a tragic but all too familiar case of soil erosion and subsidence in this tranquil and world-famous retirement estate.

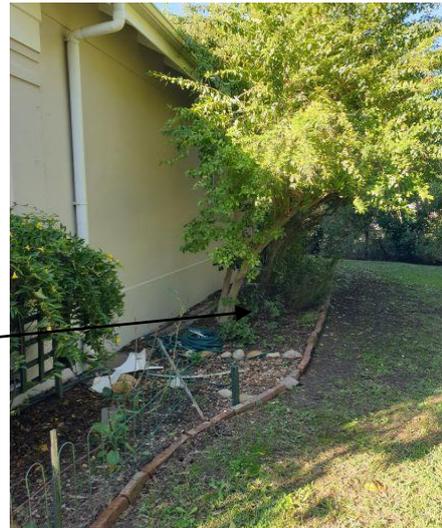
The law is clear on the tree size and distance it should be placed in expansive soil horizons:
SANS 1400-H:2012
So, the soil type dictates the proximity of the trees category:
H2 = 1m x maturity height of the tree.

In this instance the proximity of these trees should have been a minimum of 3 metres from the external walls. A blanket rule 1.5m beyond the perimeter of the house must be maintained.

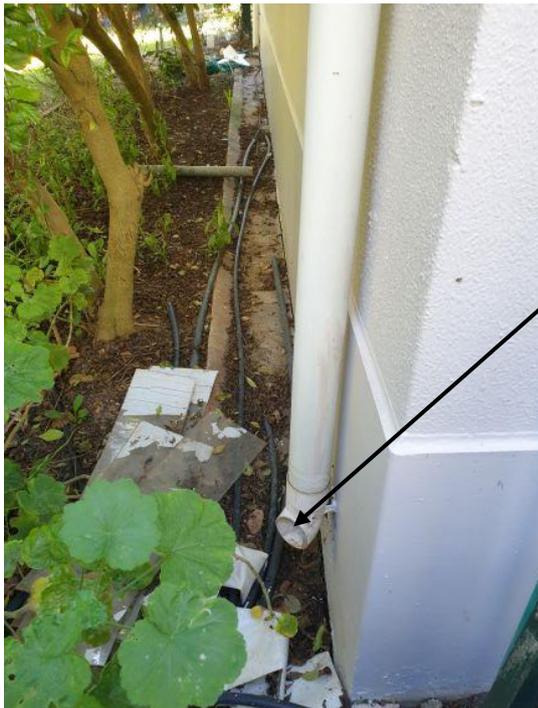
Added to this non-conformance, is the incorrect stormwater disposal from downpipes and you have a recipe for disaster. The illustration below shows the poor method of rainwater management.

Notice the end of the downpipe with no stormwater channel. The stormwater discharges directly into the soil and ponding occurs. This ponding is a trigger mechanism to a greater problem - Subsidence and Soil Erosion - the result of which can be seen in the few illustrations below.

In conclusion, it is important to remember that we need to be extra careful when deciding where to plant trees and shrubs around our homes. We must also enquire about the soil type so that we know the limitations of what and where to grow in our gardens. Please also look around your homes and ensure that all rainwater downpipes discharge into channels that lead to at least 1.5m from the house. This will safeguard against ponding of water near foundation footings.

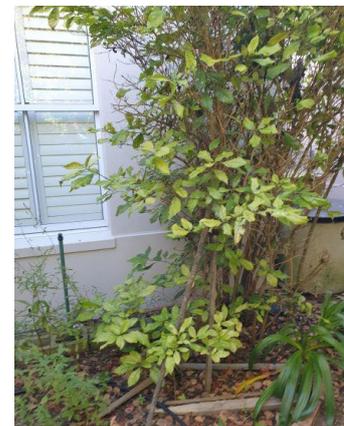
The result of the ponding water and the close proximity of the trees with its shallow root system results in settlement. In this instance the roots together with the ponding water have distorted the soil around the foundations, which have resulted in soil subsidence & large localized gaps below skirting boards and some cracking in the floor slab is evident. Furthermore, the floor tilts with a sharp fall to edge of slab.

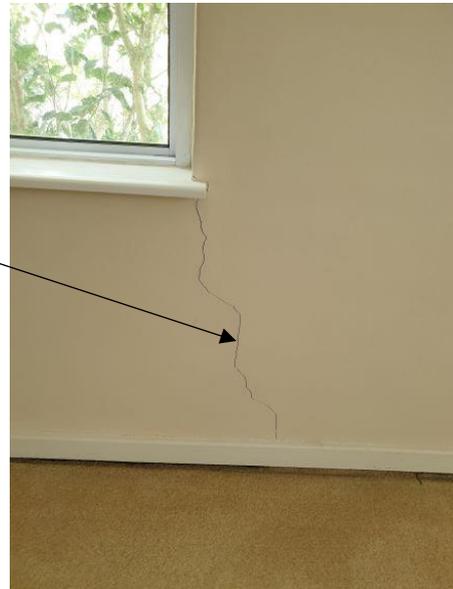
Diagonal cracking which supports distress structure. The lateral displacement indicates that movement is happening near the surface of the structure as the brickwork is rotating around the fixed masonry.

The cracks are out of plane which indicate the masonry units have lost their structural integrity and will eventually shear completely which will have a negative impact on the total structure. In some cases, the unit failure has occurred. (the masonry unit has lost its structural integrity)

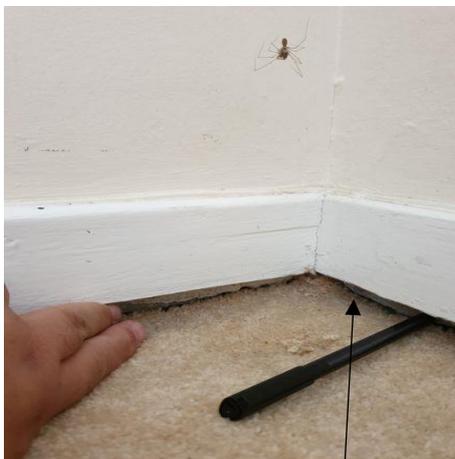
The settlement in this corner of the room amounts to just over 25mm.
Note that the slab has failed given a large diagonal crack half way through the area of the room.
